April Cottage

18th Century Grade II listed retrofit project

Prepared By Clare Fenton

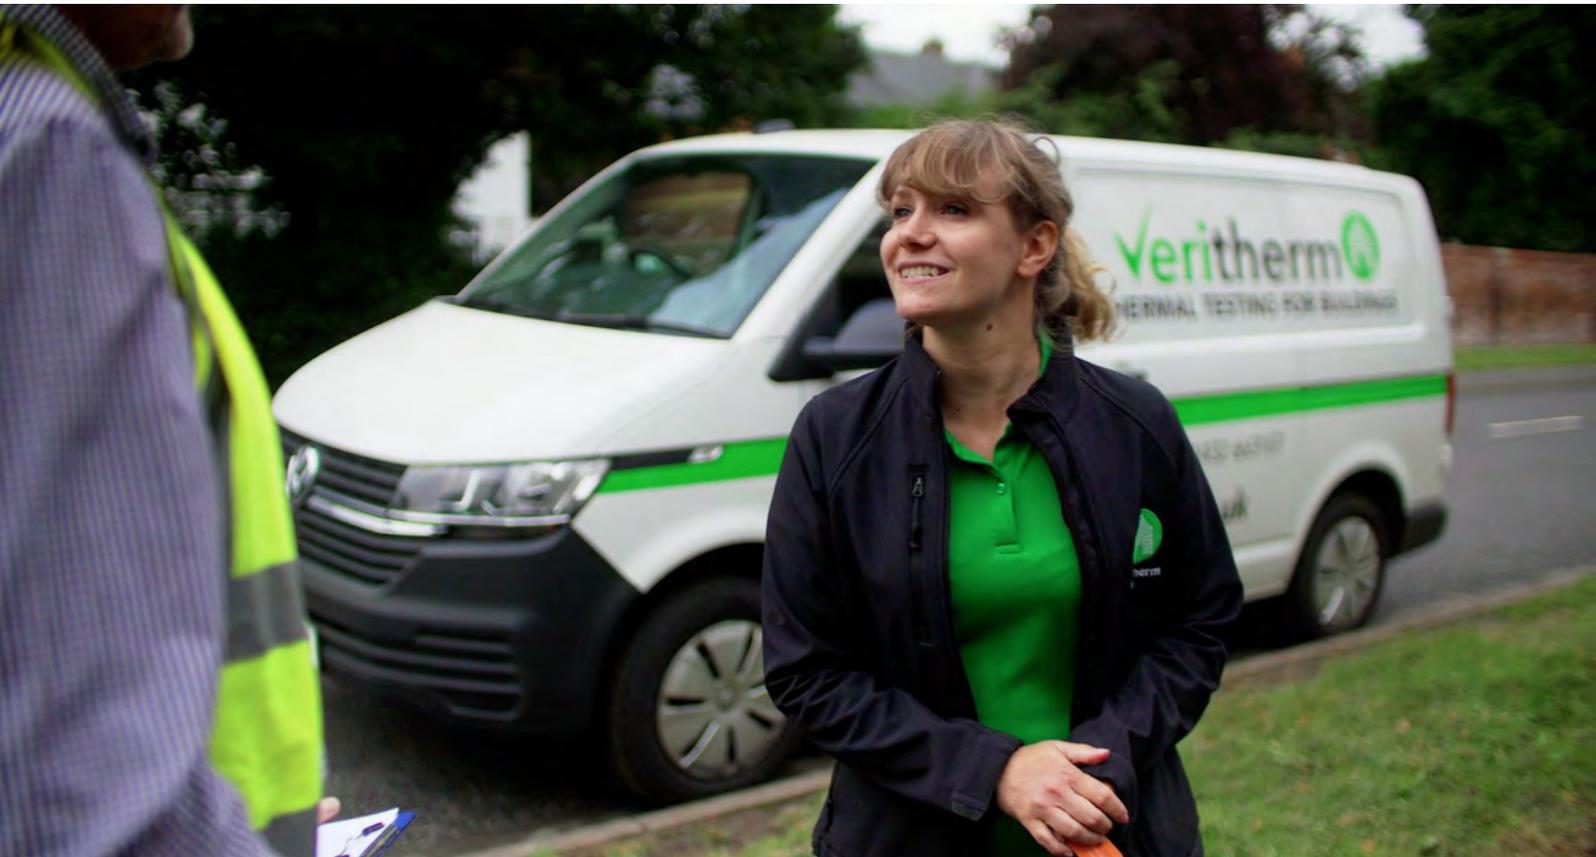
For the successful method used, in-situ measurements are performed with temperature sensors located around the house. The internal temperature of the property is elevated for 4-5 hours, and then allowed to cool passively. Our smart algorithms combine internal temperature data, external weather data, and energy data to calculate the heat loss score for the building. We also detect leaks and failures to help diagnose areas of weakness in the building fabric.
